Technical Report – R4790609825 Rev 1 CWCT – Standard for systemised building envelopes – 2005

**Echo Facades Engineering
Solutions Ltd**

Salamander BrickSlip System Test

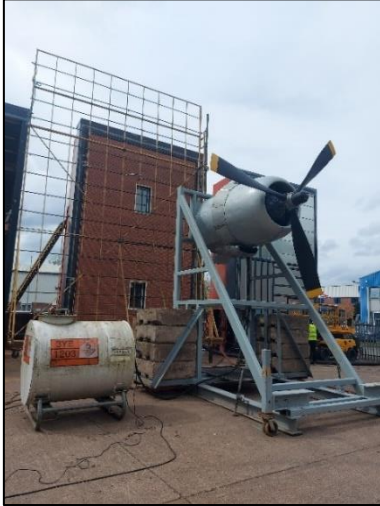
Photograph No. 1 – Dynamic Fan Test

The sample was subjected to airflow from the wind generator, as described in 4.3.2, which achieved average deflections equal to those produced at a static pressure differential of 600 Pa and these conditions were met for the specified 15 minutes.

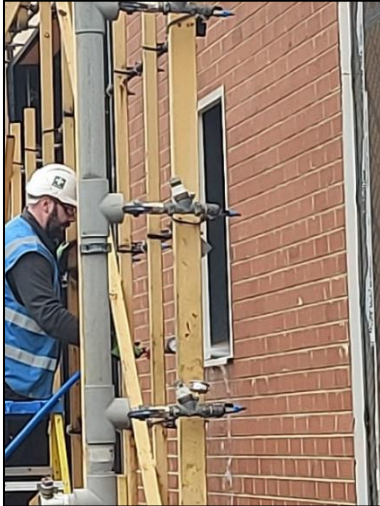
Photograph No. 2 – Hose Fan Test

Working from the exterior, the window pod interface detail between the window and SFS backing wall was wetted from the bottom up, progressing from the lowest horizontal joint then the intersecting vertical joints.

Water was applied to the sample for 5 mins per 1.5 m length of joint, as described in section 4.4.2.

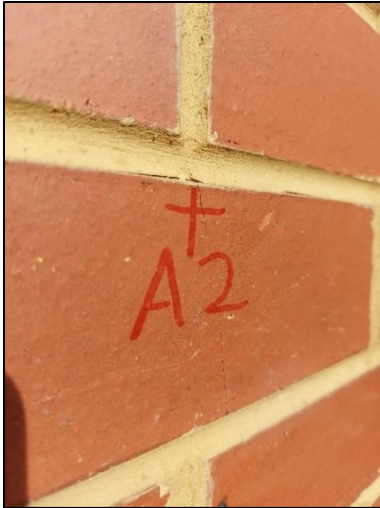
Photograph No. 3 – Damage caused following impact at location A2 Blue Zone

Blue Zone				
Impact Reference	Test Classification	Impact Energy (J)	Observations	Result
A1	Cat B	10 x 1	Cracked Brick	Class 2 Negligible Risk
A2	Cat B	10 x 1	Cracked Brick	Class 2 Negligible Risk
A3	Cat B	10 x 1	Cracked Brick	Class 2 Negligible Risk
A4	Cat B	10 x 1	No Damage	Class 1 Negligible Risk
B1	Cat B	10 x 1	Cracked Brick	Class 2 Negligible Risk
B2	Cat B	10 x 1	Cracked Brick	Class 2 Negligible Risk
B3	Cat B	10 x 1	No Damage	Class 1 Negligible Risk
B4	Cat B	10 x 1	Cracked Brick	Class 2 Negligible Risk
C1	Cat B	10 x 1	Cracked Brick	Class 2 Negligible Risk
C2	Cat B	10 x 1	Cracked Brick	Class 2 Negligible Risk
C3	Cat B	10 x 1	Cracked Brick	Class 2 Negligible Risk
C4	Cat B	10 x 1	No Damage	Class 1 Negligible Risk

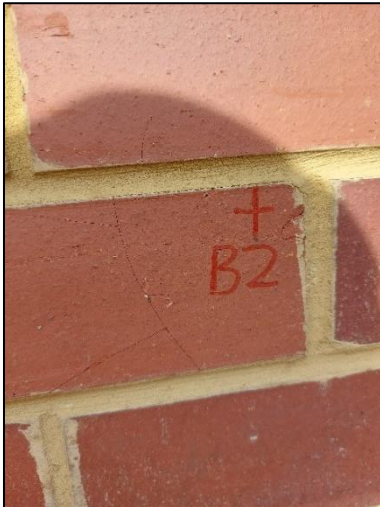
Photograph No. 4 – Damage caused following impact at location B2 Blue Zone

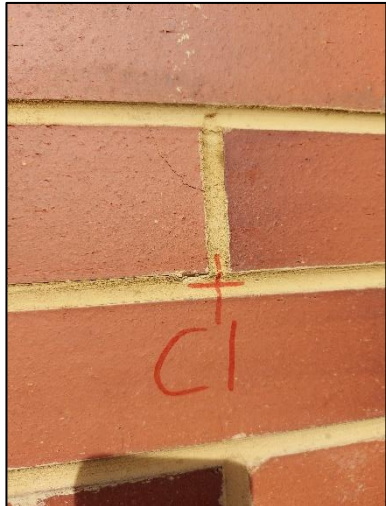
Photograph No. 5 – Damage caused following impact at location C1 Blue Zone

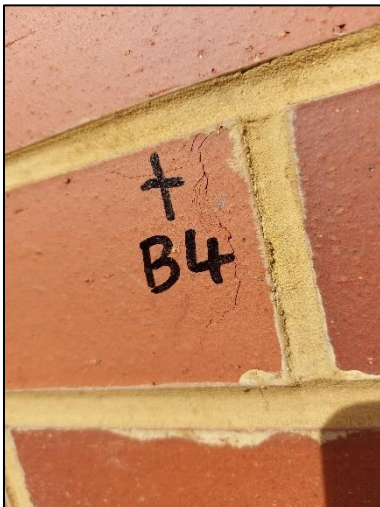
Photograph No. 6 – Damage caused following impact at location B4 Red Zone

Red Zone				
Impact Reference	Test Classification	Impact Energy (J)	Observations	Result
A1	Cat B	10 x 1	Cracked Brick	Class 2 Negligible Risk
A2	Cat B	10 x 1	Chipped/Cracked Brick	Class 2 Negligible Risk
A3	Cat B	10 x 1	Cracked Brick	Class 2 Negligible Risk
A4	Cat B	10 x 1	Cracked Brick	Class 2 Negligible Risk
B1	Cat B	10 x 1	No Damage	Class 1 Negligible Risk
B2	Cat B	10 x 1	Cracked Brick	Class 2 Negligible Risk
B3	Cat B	10 x 1	Chipped Brick	Class 2 Negligible Risk
B4	Cat B	10 x 1	Cracked Brick	Class 2 Negligible Risk
C1	Cat B	10 x 1	No Damage	Class 1 Negligible Risk
C2	Cat B	10 x 1	No Damage	Class 1 Negligible Risk
C3	Cat B	10 x 1	No Damage	Class 1 Negligible Risk
C4	Cat B	10 x 1	No Damage	Class 1 Negligible Risk

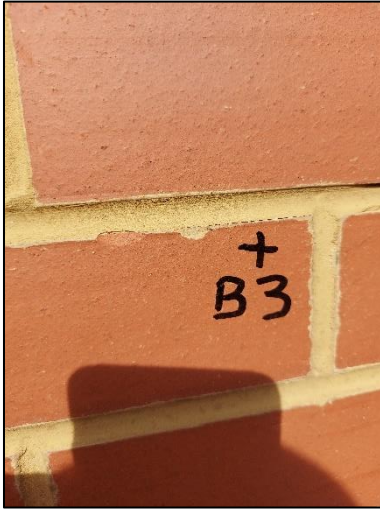
Photograph No. 7 – Damage caused following impact at location B3 Red Zone

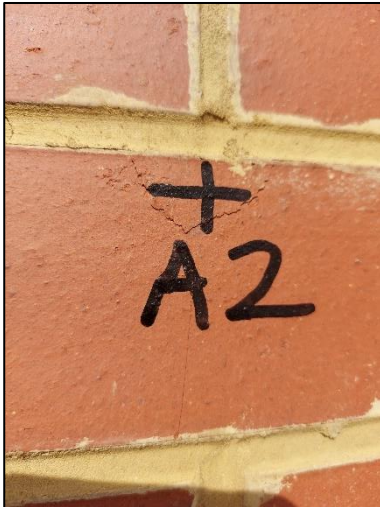
Photograph No. 8 – Damage caused following impact at location A2 Red Zone

Photograph No. 9 – Damage caused following impact at location A2 Red Zone

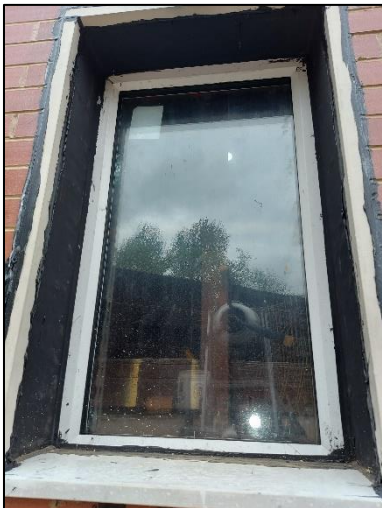
Photograph No. 11 – Window pod detail

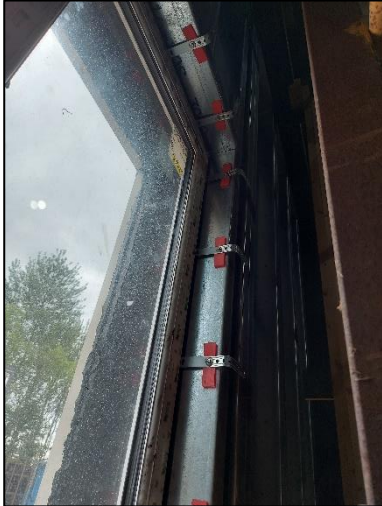
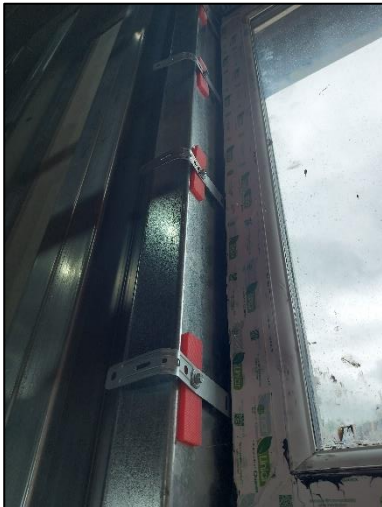
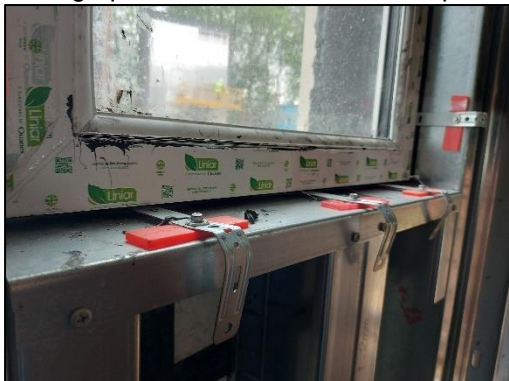
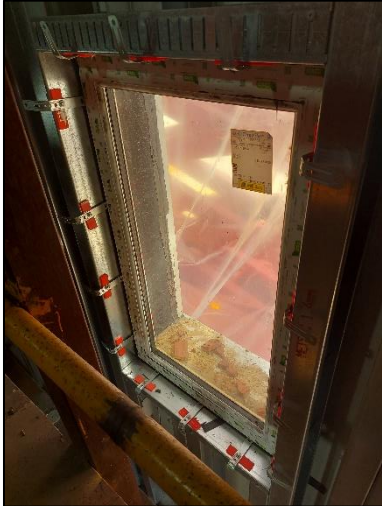
Photograph No. 12 - Internal window pod detail

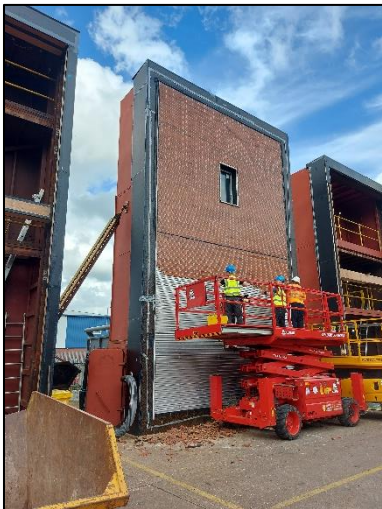
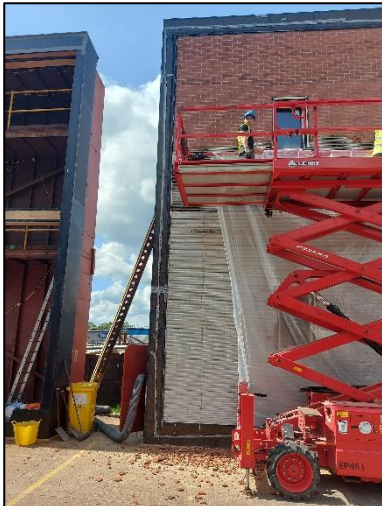
Photograph No. 16 - Sample with bricks partially removed

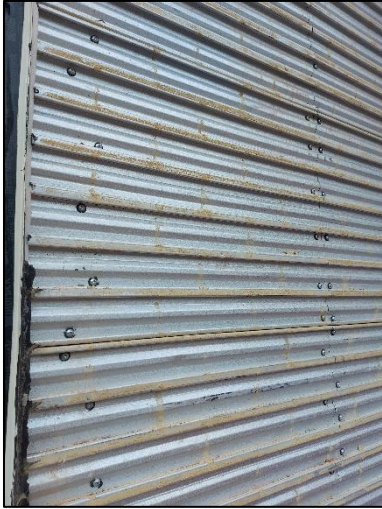
Photograph No. 18 - Brick Carrier rails

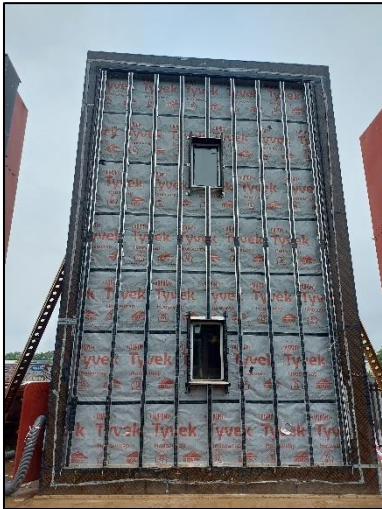
Photograph No. 19 – Backing wall and vertical rails

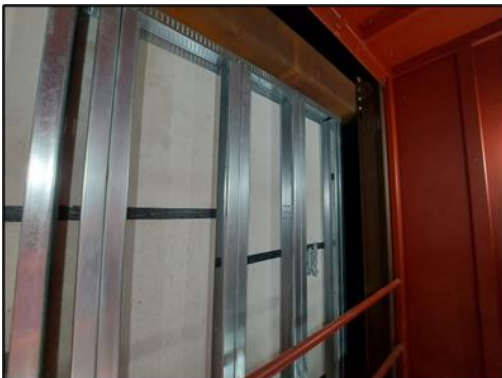
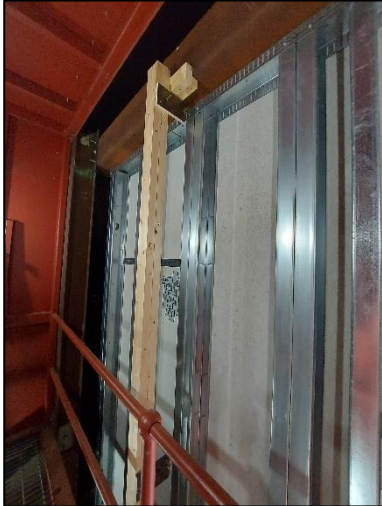
Photograph No. 20 – Internal view of SFS
